# Kinematic Analysis of Landslides: A Case Study Along Jerash-Amman Highway, Jordan

Abdullah Diabat<sup>1</sup>, Majed Ibrahim<sup>2</sup>, Yasmeeen Al-Hawareen<sup>3</sup>

<sup>1,3</sup>Earth and Environmental Sciences Department, Al al-Bayt University, Al-Mafraq, Jordan

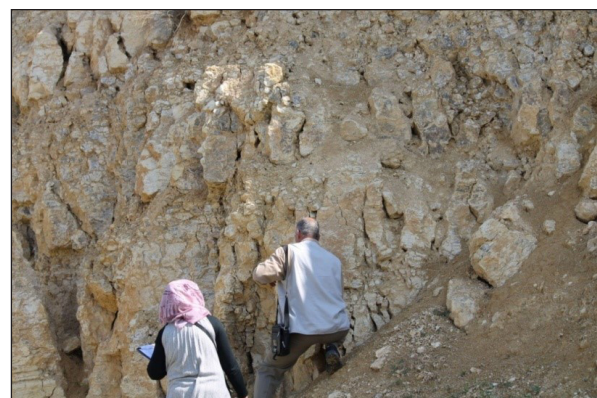
This station is located in the city of Jerash, near Jerash University and 40 km north of the capital Amman (Fig. 3). The outcrop is part of the Na'ur Formation, it is highly fractured and highly weathered limestone (Fig. 7).

**Figure 7.** Highly fractured and weathered rocks in an outcrop of station-1.

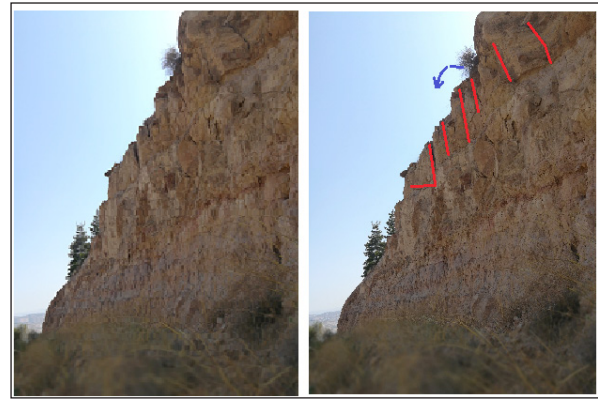
J4(80/150), and J5 (88/255). The result shows that probable toppling failure towards WSW (255 °) at J1 (Fig. 9), this is expected because the dip direction of the J1-set is in the opposite direction of the slope face. Figure (9) shows two wedge failure directions along the line of intersections of J2 and J3 (J23), J2 and J4 (J24), respectively towards 40/210° and 60/220°. It is important to note that the wedge sliding along J24 is in its critical case because the intersection point of J2 and J4 lies at the slope face (Fig. 9). Despite the dominance trend of J5 (Figs 8 and 9), the results of the kinematic analysis indicated that it is stable because the dip of discontinuity planes is greater than the slope angle and lying out of the area of probable failure. Figures 10 and 11 show examples of toppling and wedge failures in station 1, respectively.

**Figure 10.** Probability of toppling failure, vertical joints (red lines) show back release surfaces.

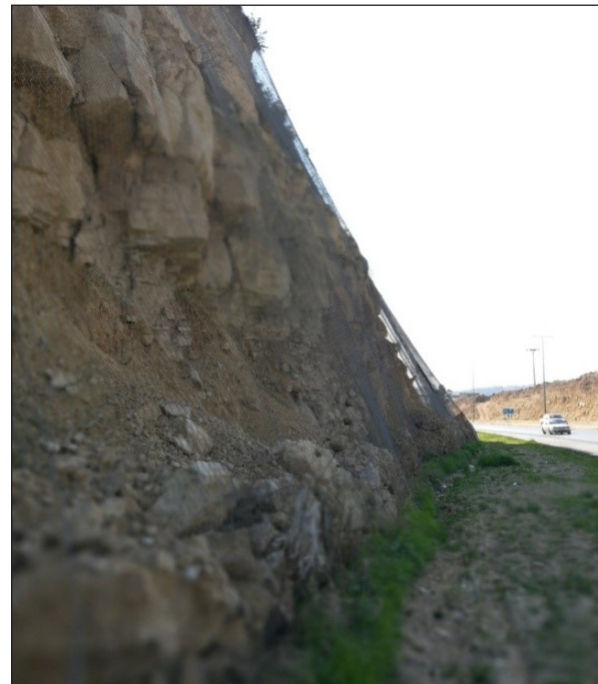
**Figure 11.** Shows wedge failure and the protruding overhanging rocks at the slope face.

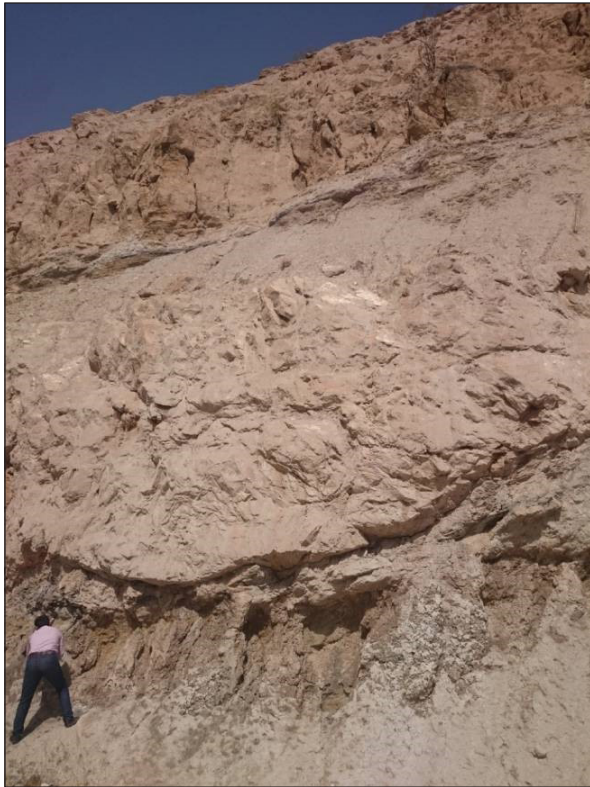
**Figure 12.** Front view of the Kurnub outcrop with lenses of clay and shale in station 2.

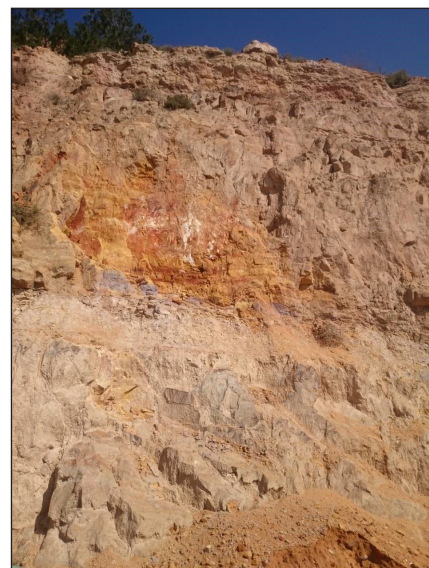
**Figure 15.** Very steep slope face towards the highway in the Kurnub outcrop of Station-3.

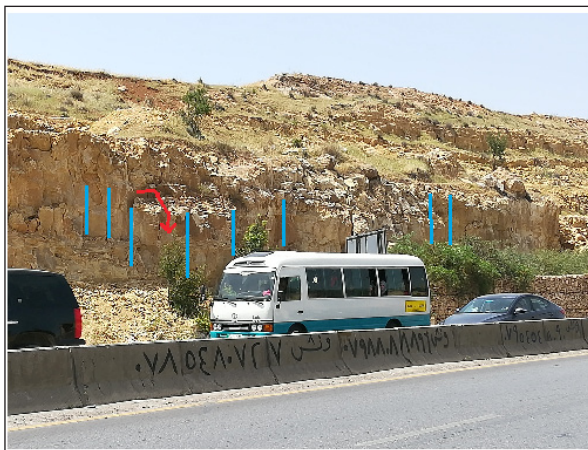
**Figure 21.** Vertically jointed Naur limestone cliff (blue lines) probable to topple in station-5

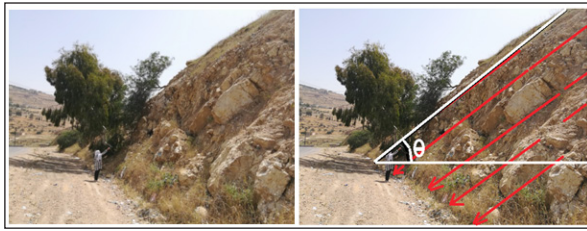
Figure 24. Plane sliding in station- 5.

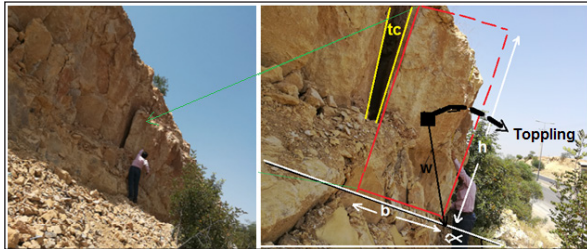
Figure 25. Toppling failure; tension crack (tc) acts as back release surface in station-5.

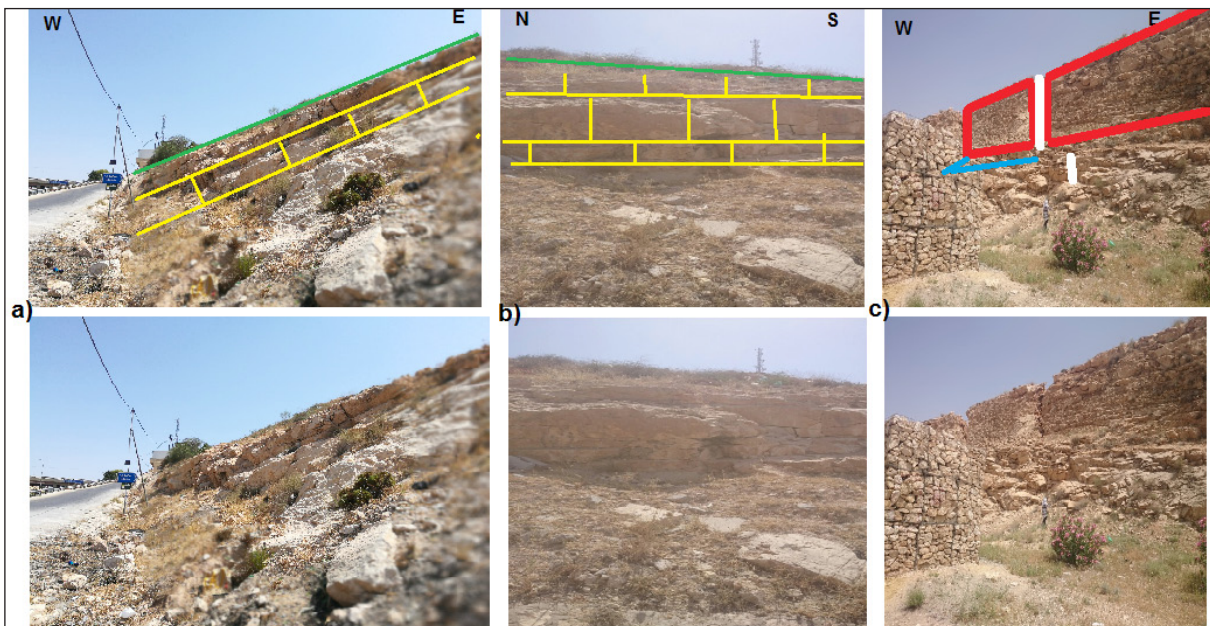
Although the dip angle of bedding planes are not exceeding  $30$  to  $35^{\circ}$ , landslides have occurred. This station represents an ideal example of an active man-made landslide failure, the outcrop was stable before cutting the foothill during the construction of the highway in the 1990s. The cutting process of the foothill led to increasing the shear forces against the normal and resistance forces, and creating tension cracks a few meters in depth and width (Fig. 29). The thick-bedded limestone in Naur Formation, and the presence of some thin marl beds which has high susceptibility of water absorption and seepage during the rainfall led to lubricate and facilitate the plane sliding (Fig. 30).

Figure 26. Side view of stable rock mass unaffected by cutting, b) Front view, c) Sliding rock mass has been affected by the direct cutting of the slope foothill in station-6.

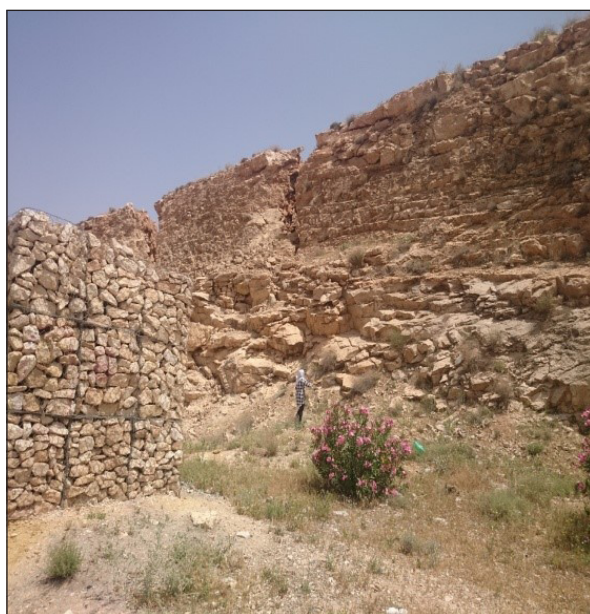
**Figure 29.** The active landslide along the highway in the Salhub area after cutting the foothill in station-6.

Station-6 which represents a major active landslide was analyzed through this study to show an ideal example

(of mistake) of the active man-made landslide failure, that happened during road construction. In Station-7 it was difficult to take measurements of data orientation because it is characterized by friable sandstone and has highly weathered and fractured rock blocks. In Station-8 it was also difficult to take measurements of data orientation because it is characterized by a steep slope with a smooth surface and highly weathered rocks.

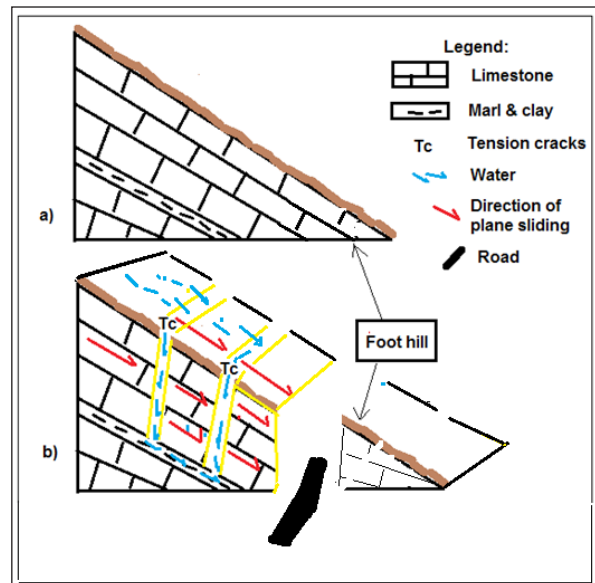
**Figure 30.** Schematic diagram showing what happened and to shed light on the manmade problem in station 6.

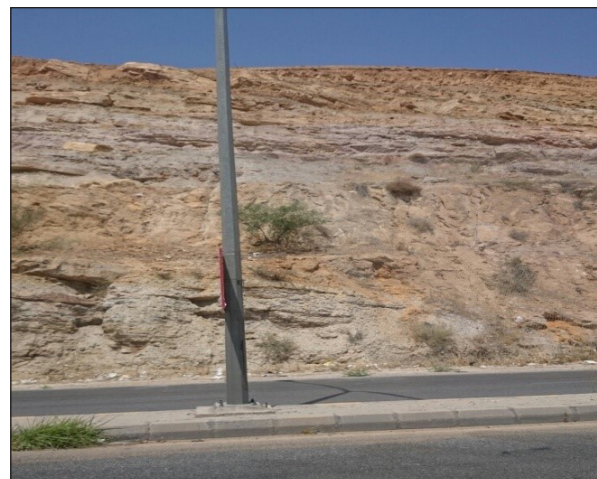
**Figure 31.** Front view of the outcrop with lenses of clay in station 7.

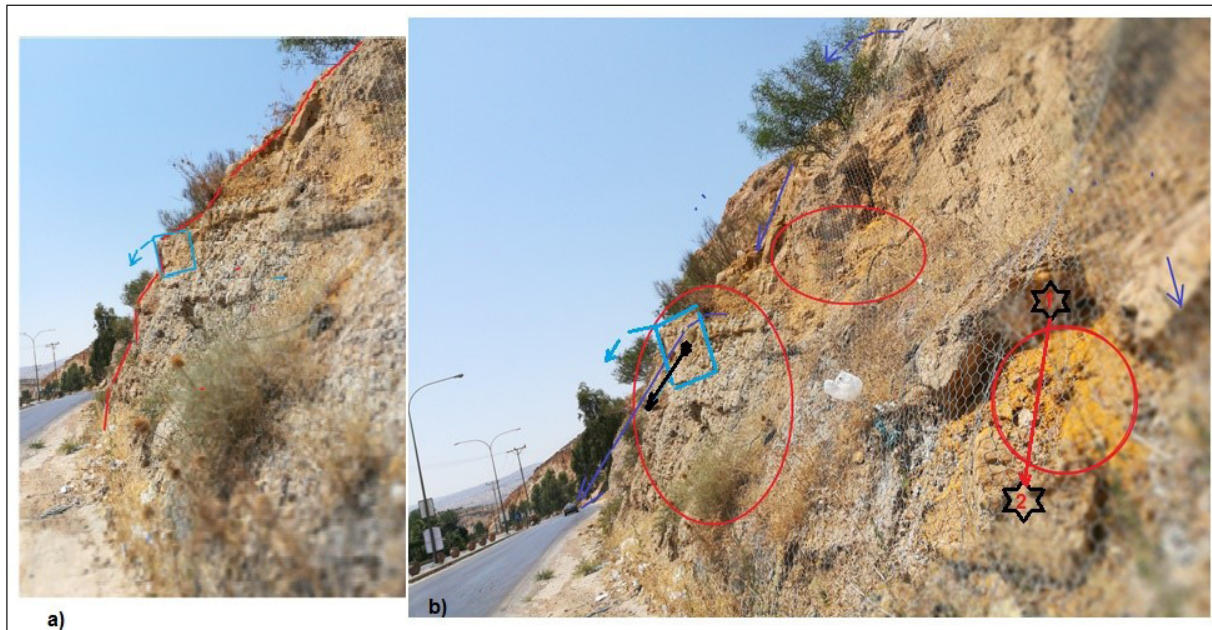
This station is located along the old Jerash-Amman road about 2 Km south of Jerash city. It is located at  $32^{\circ} 13. 705' N$  and  $35^{\circ} 53. 605' E$  (Fig. 3). The outcrop is part of the Kurnub group, medium to thick-bedded, yellow to dirty white, friable, fine to medium grained, quartzitic, massive and cross-bedded, interbedded with shale beds and clay lenses (Fig. 31). It was difficult to take orientation data measurements in this station because it characterized by friable sandstone and has highly weathered and fractured rock blocks. It also has a steep slope, therefore rock falls and toppling is probable in this station (Fig. 32).

**Figure 32.** Side view of the Kurnub outcrop in station-7, it is yellow to dirty white, friable sandstone (red circle), highly weathered, and highly fractured (red ellipses). The block highlighted blue will topple, the black stars show the topple and slide the block from location 1 to 2.

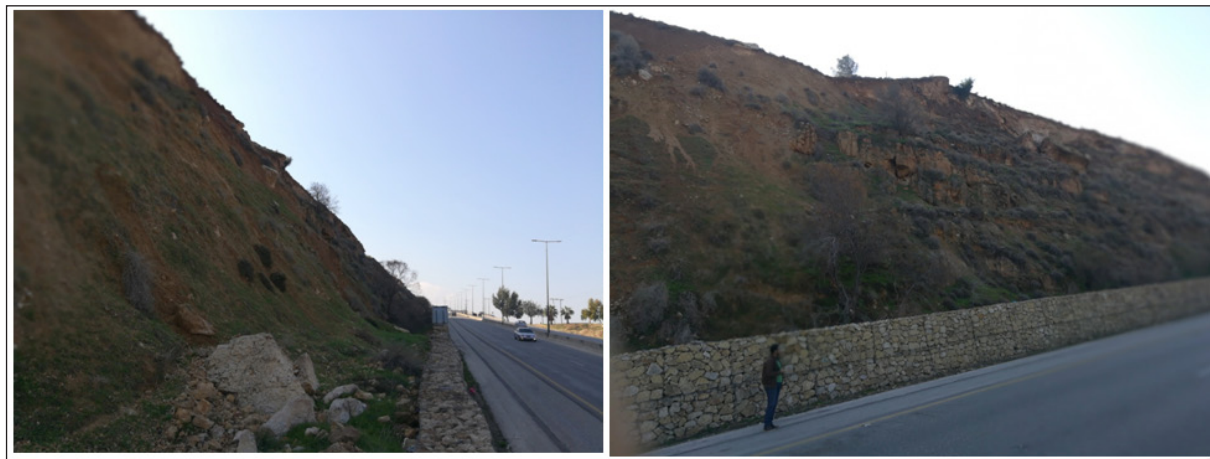
This station is located about 500 m south of Zarqa River. It is located at  $32^{\circ} 12. 343' N$  and  $35^{\circ} 52.251' E$  (Fig. 3). The outcrop is part of the Kurnub Group, which is characterized by highly weathered and friable sandstone. It was difficult to take orientation data measurements from this station. It is characterized by a steep slope with a smooth surface, which led to easier fall down limestone blocks from the Na'ur Formation above (Fig. 33).

**Figure 33.** Kurnub outcrop in station- 8; a) side view, b) front view.

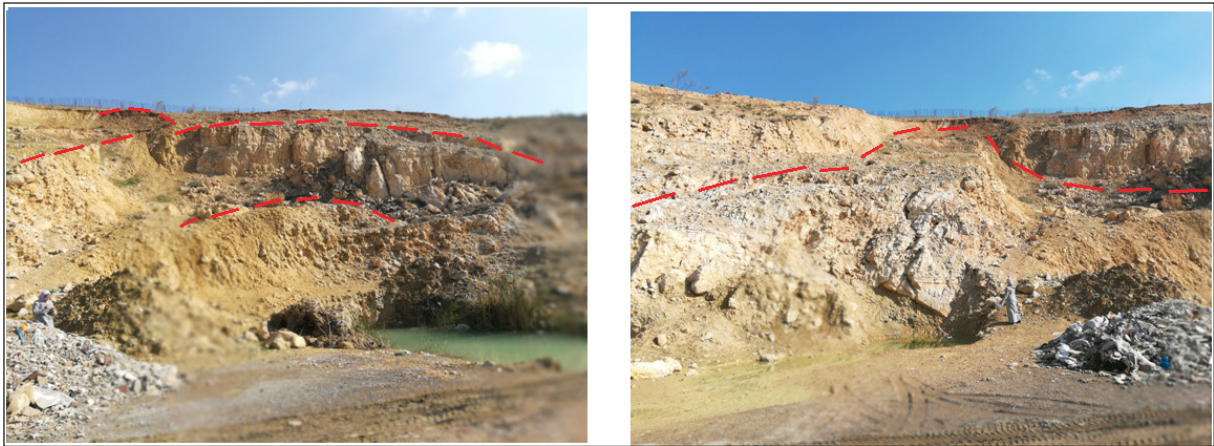
Figure 35. The outcrop shows the circular failure in station-9.

Station-9 has highly fractured rocks which resulted in a circular failure, whereas some fractures with preferred orientation in NNW-SSE to N-S resulted in toppling. These fractures (J1) beyond the rock mass act as the back release (tension cracks) and will lead to toppling. The results of the kinematic analysis in the study area show that the wedge failure in stations 1, 2, 3, 4, and 5 between joints (J2 and J4, J2 and J3), (J3 and J4), (J2 and J3), (J1 and J4, J2 and J4, J3 and J5), (J1 and J6, J1 and bedding, J3 and J6, J3 and bedding, J2 and J3). Toppling failure in stations 1, 2, 5, and 9 between the joint sets J1, J2, J4, and J1, respectively. Plane failure in stations 2, 3, 4, and 5 along the joint sets J1, J1, J5, and bedding, respectively. Whereas, circular failure was only observed in station 9. Based on the results of the current study the landslides were delineated and displayed on the land sat and on the geological map of the study area (Fig. 38).

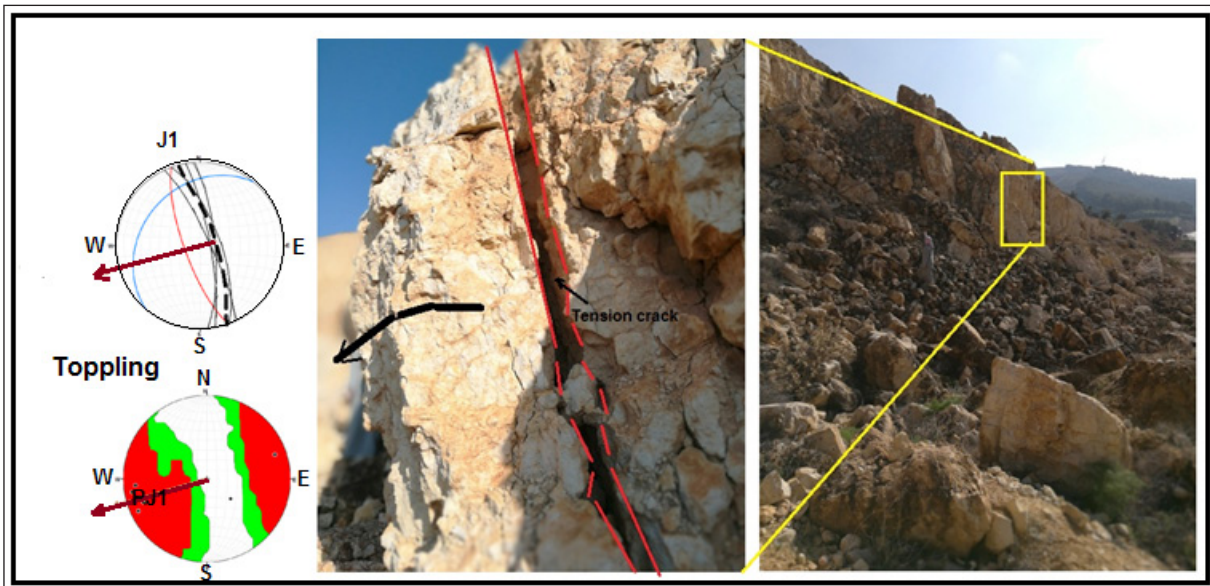
Figure 36. Toppling failure along J1 towards WSW (see the tension crack acts as back release surface) in station-9.
