Analysis and Modeling of the Hydro-Mechanical Behavior of Ain El Hammam Landslide, Algeria

Fazia Boudjemia* and Bachir Melbouci

Laboratory of Geomaterials, Environment and Installation (LGEA), University of Mouloud Mammeri - Tizi-Ouzou, Algeria

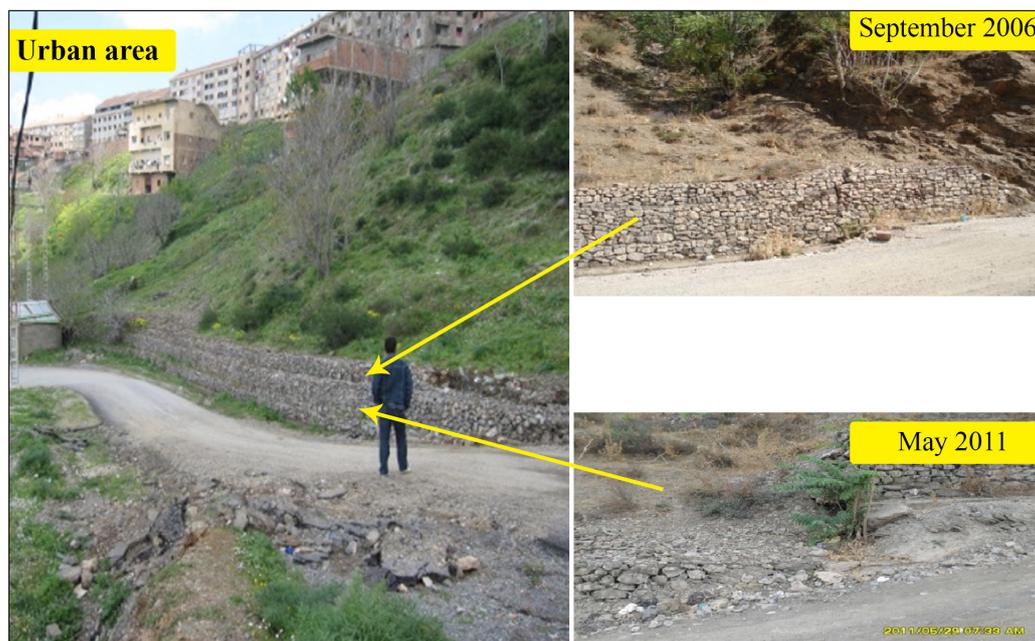
Figure 1. Propagation and evolution of the slide downstream of the slope.

Stretching over 150 m in length between the summit and the frontal part of the slope, the slip began to describe a more complex form until it reached some of the slope on the south-east side beside the road leading to Ait Sidi Said (Figure 1).

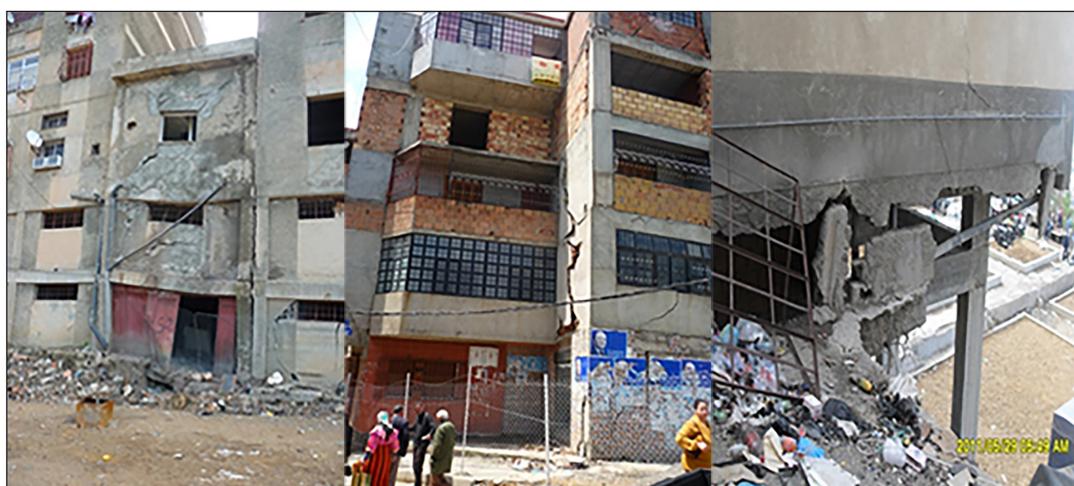
Figure 2. Obstructions observed in buildings.

During winters with heavy rains, the movement of the land continued to spread in a strong and steady manner. In the winters of 2008-2009, some particular and marked disorders appeared, such as a distortion of buildings and retaining walls (Figure 2), and also crevasses on the roadways (Figure 3).

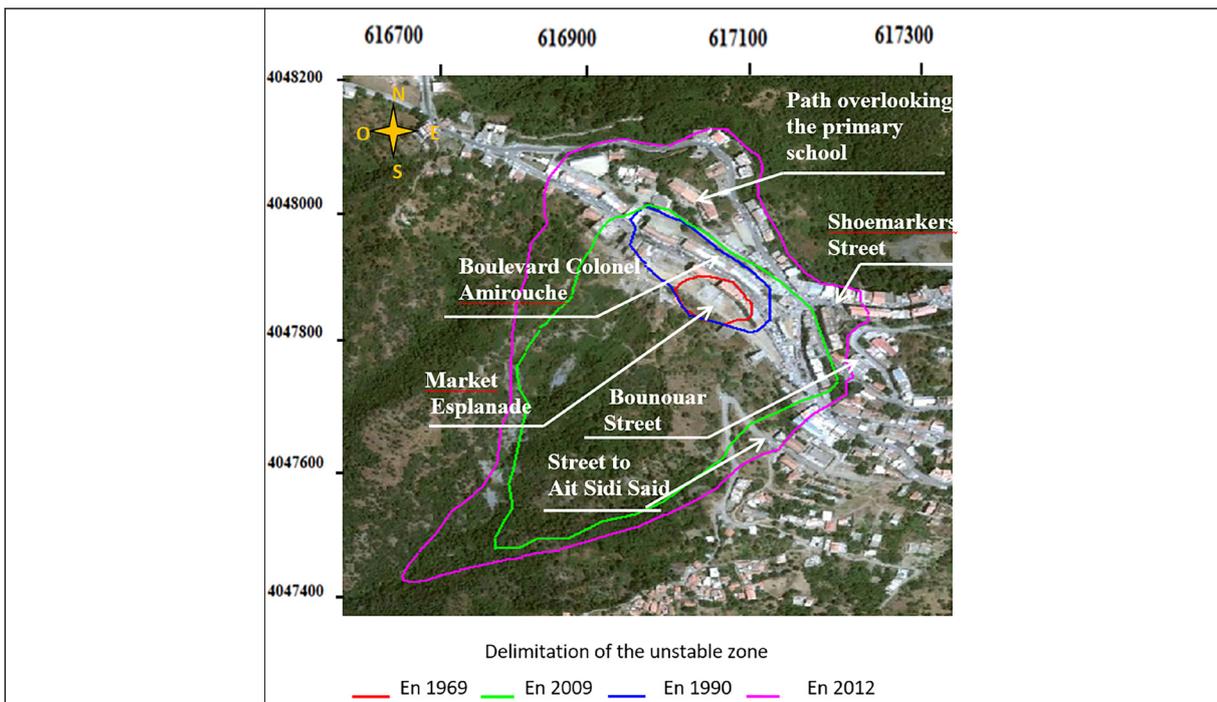
Figure 4. Evolution of the area of landslide (Djeral and Melbouci, 2013), and locating the principal places affected by the movement.

was closely monitored, following the propagation of the movement towards the median and lower zones of the slope (Figure 4). Prospecting work has been initiated since October 2009 by setting up a network of points subject to topometric measurements in order to define the kinematics of the movement (displacement reaching 50 cm over a few zones during a period of six months).

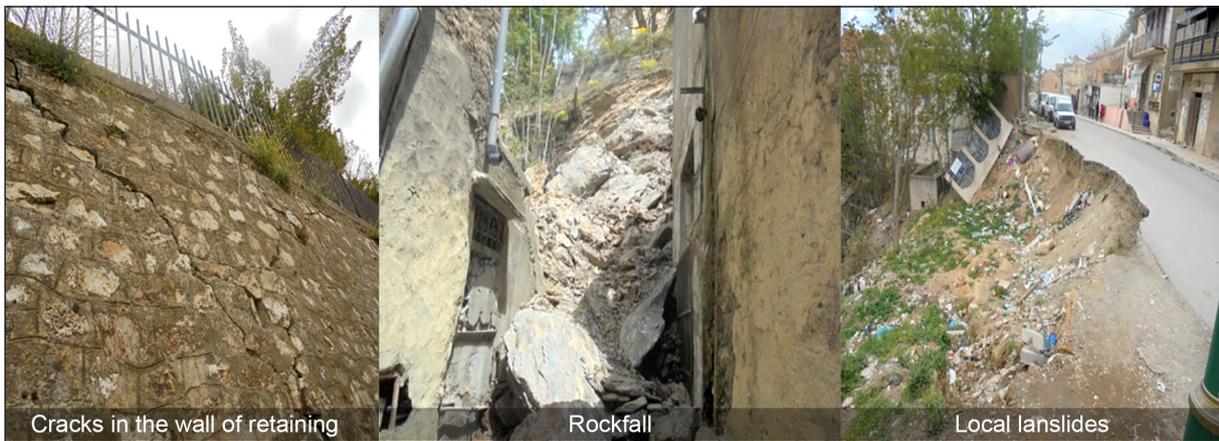
Figure 5. New instabilities registered in 2016.

period. This, without neglecting the new local instabilities, appeared in particular, on the Shoemaker street (Figure 5), as well as during the renewal of numerous cracks in the retaining walls and ways, which are filled in by public services each time.

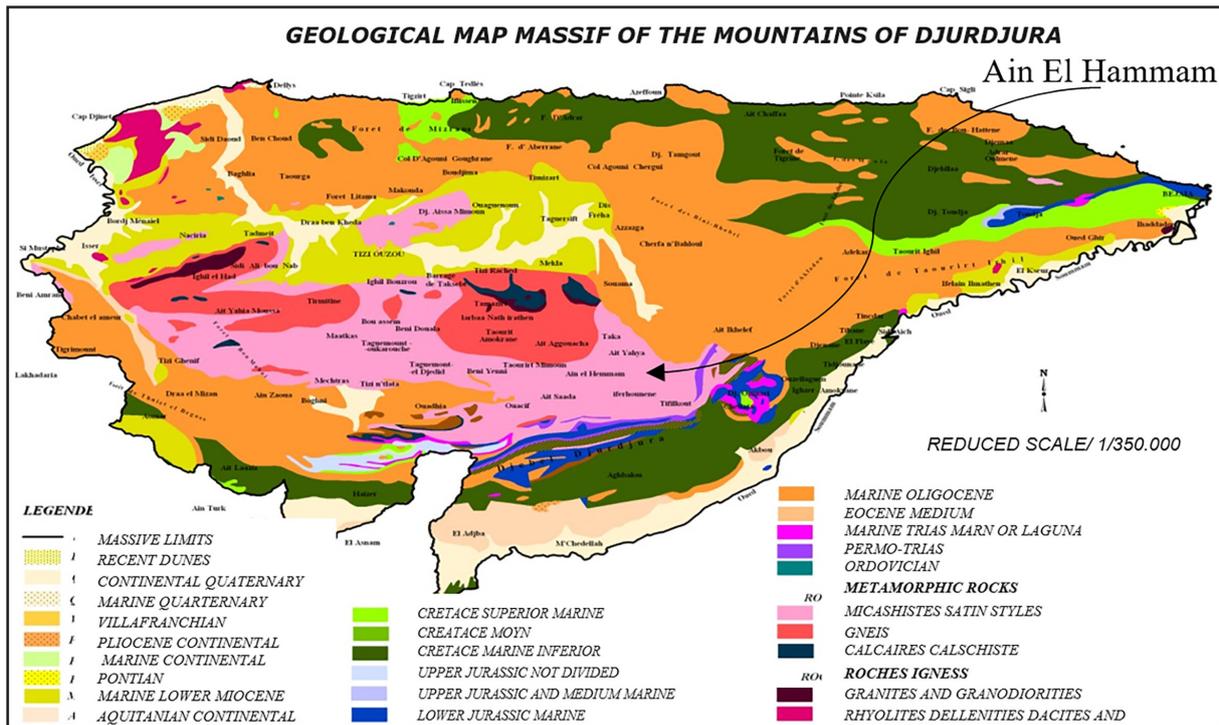
Figure 6. Geological map showing solid masses of the mounts of Djurdjura (CENEAP-MATET, 2010).

The district of Ain El Hammam belongs to the internal zones of the chain of Maghrebides. In this area, the Kabyle crystallophyllian base was found to be mainly composed of metamorphic massifs, namely, gneisses, marbles, micachists, and schists (Figure 6). This base is, in some places, unconformably covered by detrital deposits of the upper Oligocene-lower Miocene age, named Oglio-Miocene kabyle (Durand-Delga, 1969).

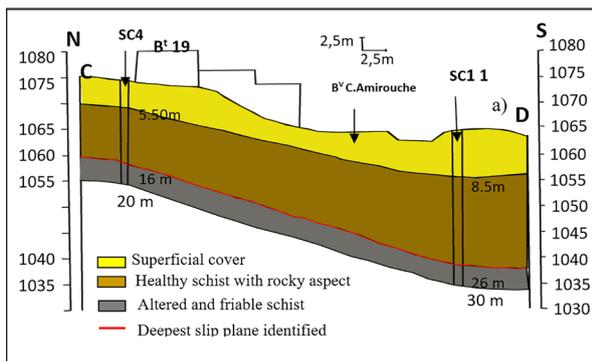
Figure 7. Geological section made by GEOMICA laboratory (2009)

On the slip zone, a detrital sequence of grayish satin schists, containing fine quartzite-rich levels and a predominantly clayey-silty cover, constituting the upper unit (Figure 7).

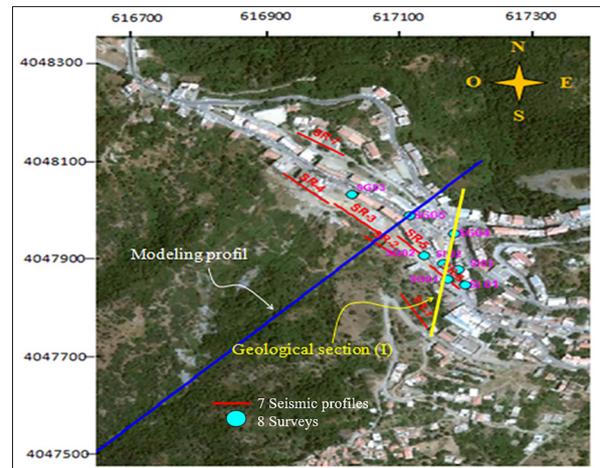
Figure 8. Locating the profile used in the modeling and the geological section defined by figure 7.

dimensional effects of the model will not be very significant, a two-dimensional profile (Figure 8) was, therefore, chosen.

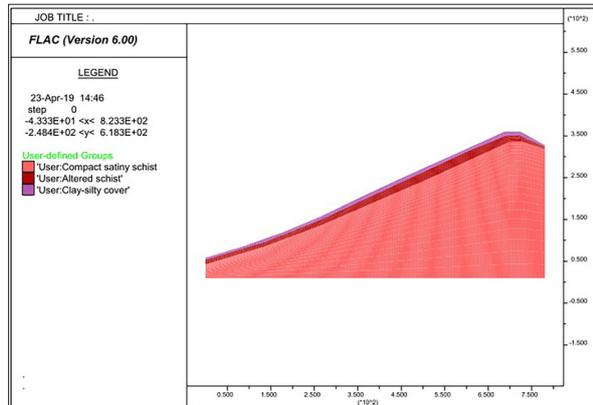
Figure 9. Calculation model.

The section of the slope is represented from top to bottom by the stratigraphic formations below (Figure 9) using the geotechnical characteristics defined by the Mohr Coulomb rupture criterion (Table1).

- A clay-silty cover with a thickness of 3.5 to 10 m.
- A layer of altered schist with a thickness of 20 m.
- The compact satiny schist that constitutes the rock substratum.

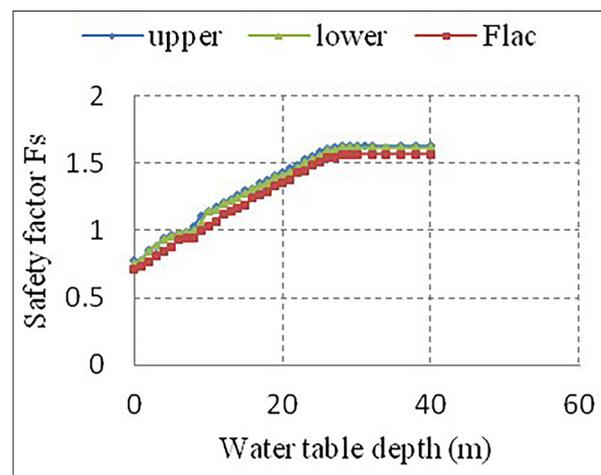
Figure 10. Comparison of the curves of variation of the safety factor as a function of the water table depth obtained with the three calculation methods.

Before analyzing the stability results, it is necessary first to examine the results of the comparison of the safety factor values (Figures 10 and 11) obtained by the three calculation methods.

As preliminary remarks on this subject, the three curves retain the same pace over all the ranges of the chosen parameters and sometimes nearly touch them. Although the Flac software underestimates the stability of the slope compared to the limit analysis methods, the three methods give very close safety factors, and estimate, in the same way, the stability of the slope. For example, using the three methods, the limit equilibrium (Fs = 1) is reached practically with the same parameters.

Moreover, it is evident that the static method gives values of the safety factor lower than those obtained by the kinematical method. In fact, the first seeks a lower bound value of the safety factor using a field of stresses, whereas the second determines an upper bound value using a field of displacements or velocities. In result, the search for the lower and upper boundaries makes it possible for each

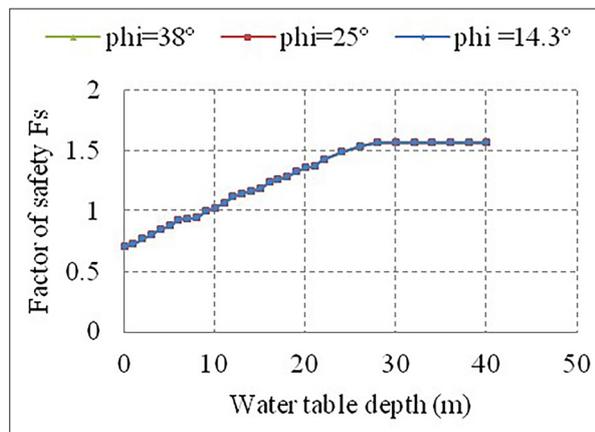
Figure 12. Curves of variation of the safety factor as a function of the water table depth.

Calculations of the safety factor F_s and the corresponding displacements are carried out through a wide range of configurations which represent more or less effective precipitation; the results have clearly illustrated the significant role of the hydraulic parameter. In fact, it is quickly noted that with the fall down of the water table, the safety factor F_s increases progressively along the first part of the curve (Figure 12), on which a linear increasing of F_s is mostly seen with the increase of the depth of the water table until 28m.

Over 28 m, F_s remains constant (horizontal curve) and equals 1.57 ($F_s = 1.57$). This value corresponds to the same state of stability as that found in the absence of the water table, which means that after this depth, water has no effect on the stability of the slope. It must be noted that this level corresponds to the interface delimiting the bedrock and that this is considered as a continuous medium.

In this context, it should be noted that any increase in the friction angle alone does not offer any margin of safety even at fairly high values, thus, the safety factor is the same for the three values of φ in each piezometric level. This is clearly seen in Figure 12 where the three curves are merged.

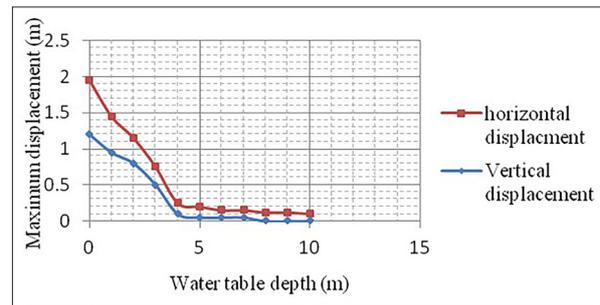
Figure 13. Curves of variation of horizontal displacements and vertical displacements as a function of the water table depth.

For variations, of maximum horizontal and vertical displacement values with the increment of the depth, the curve (Figure 13) marks a quick and intense fall down of displacement with the depth of water table between the ground surface until 4m depth. Underneath this level,

there is a second stage throughout displacements which is diminished slowly to be cancelled out at a 9 m depth where the slope has experienced the limit state of stability.

It should be pointed out that over the whole range of the water table depths, the horizontal displacements are greater than the vertical displacements; the maximum amplitude for the horizontal displacements has occurred at the frontal part of the ridge.

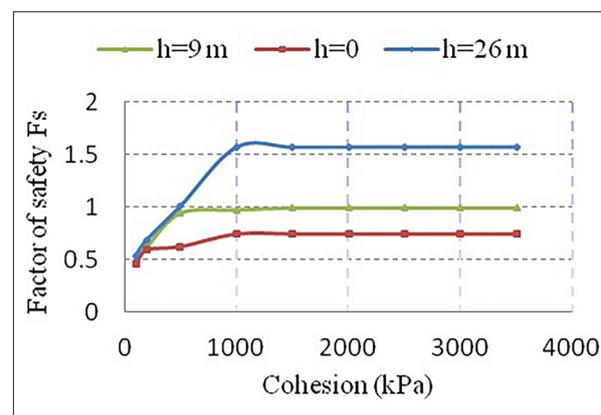
Figure 14. Curves of the coefficient of safety as a function of cohesion.

For the low cohesion ($C = 100$ and $C = 200$ kPa) corresponding to highly fractured schist, the safety factor remains low even at a sufficiently stabilizing piezometric level. These conditions correspond to circles of sliding so deep to the point that they can't be considered very realistic.

Although a small increase of C value ($C = 500$ kPa) leads to an improvement of the stability, this improvement, however, is very limited and is mainly dependent on the

level of the water table. In fact, when the soil is completely saturated with water, the safety factor is less than 1 within the entire cohesion range. From $C = 1000$ kPa upwards, $F_s = 0.75$, and it remains constant.

At a moderate piezometric height $h = 9$ m with a high C value ($C \geq 1500$ kPa), the state of stability is very critical. Consequently, the improvement of the cohesion alone does not give any satisfactory evolution of the state of stability.

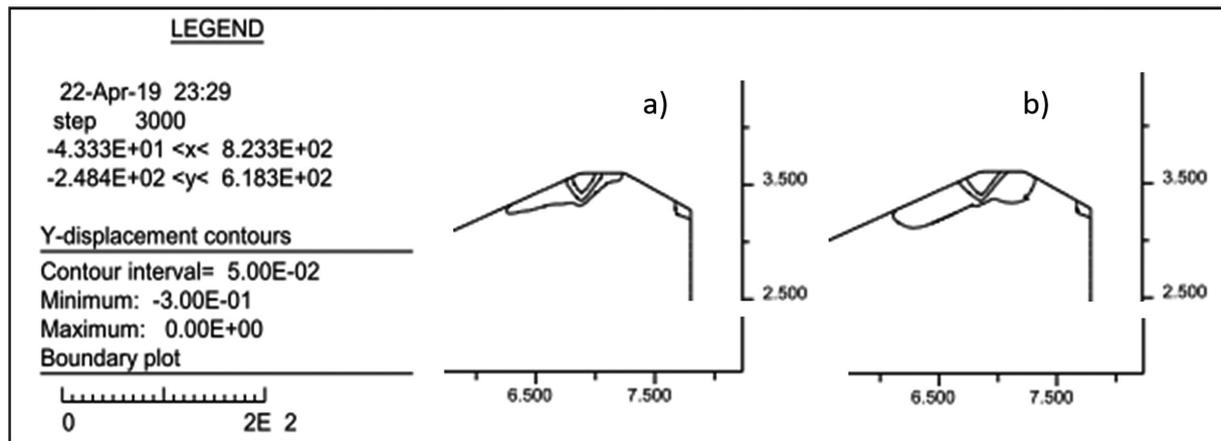
Figure 15. Isovalue lines of vertical displacements. (a) Before loading. (b) After loading.

The results of this study investigate the spread off of the displacements and their progression downstream and upstream of the slope (Figure 15) as well as the appearance of a new sliding plane defined by the

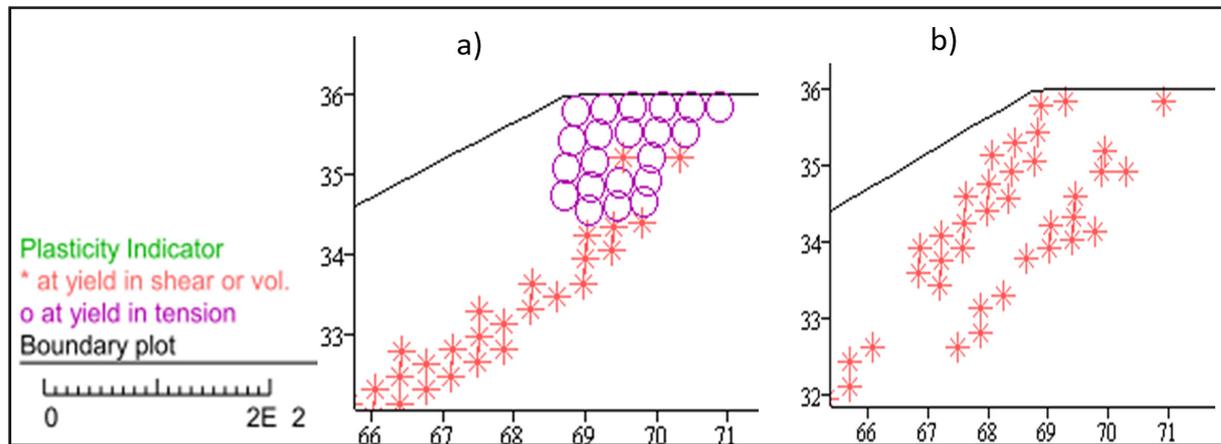
Figure 16. Areas of plasticity (a) Before loading. (b) After loading.

propagation of the areas that have over crossed the plasticity state (Figure 16). It should be noted that these zones had an elastic behavior before the application of the load.

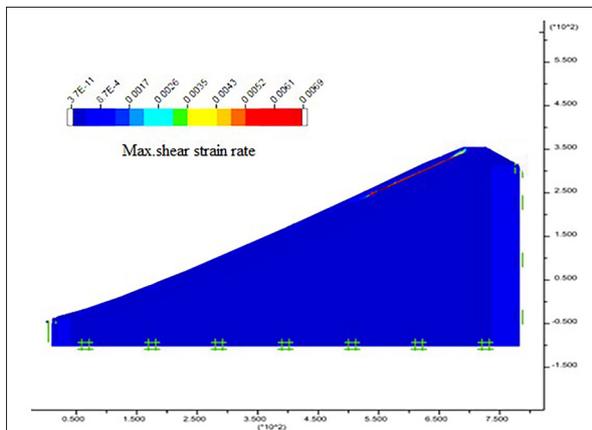
Figure 17. Failure mechanism 1 (Short term limit analysis).

The short-term calculations carried out using the OptumG2 software, considering the water table level with the free face of the slope, show an instantaneous slip marking a plane rupture line along the superficial overlay-altered schist interface (Figure 17), along a 150 m length at a depth not exceeding 10 m. This configuration represents, on one hand, the hypothesis of the superficial slip envisaged by the ANTEA laboratory (2010), and on the other hand, the hypothesis of rupture 1 defined by Djerbal and Melbouci (2012). This type of slip can occur during winter seasons with heavy rains causing mobilization of the soft and completely saturated cover.

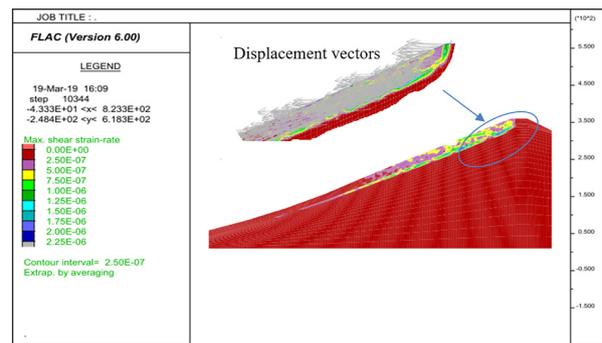
Figure 18. Tensile crack observed near a single structure at the top of the slope.

The direction of the displacement vectors, however, shows that there is a tension at the level of the urbanized part of the slope at the altitude of 1075m, which is well confirmed by the fairly deep-tension cracks observed on road RN 15 at the market place, and also below the constructions at the top of the slope (Figure 19).

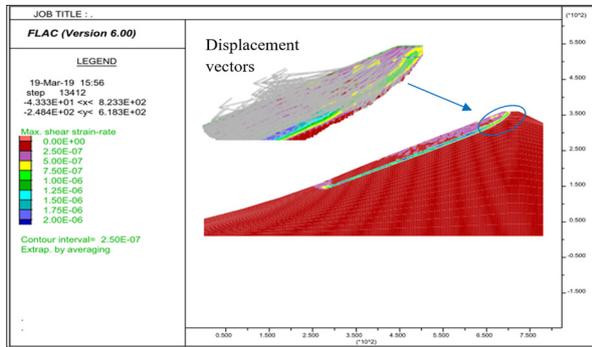
Figure 20. Failure mechanism 3 (Moderate piezometric height).

For the volume delimited by failure mechanism 2 (Figure 20), the drainage conditions surely modify the nature of the failure surface. In fact, with the drawdown of the water table to a 4m depth ($h = 4m$), and combined with relatively high cohesions ($C = 1000$ to 3500 kPa), the failure is located at the altered schist-healthy schist interface, and sets the superficial layer in motion as well as the whole slice of the altered shale within a large drop level (about 200m) and a length of 450 m. The displacement vectors show an overall downward movement in the direction of the slope, marking the foot of the slide at the altitude line of 900 m. This movement may be sustained by the smooth and plastic nature of the formation in contact with the healthy masses (Djerbal and Melbouci 2012), causing a considerable drop in the resistance of the overlying layers. Inside the body of the slip, the strains decrease by nearly 50% in comparison with failure mechanism 2.

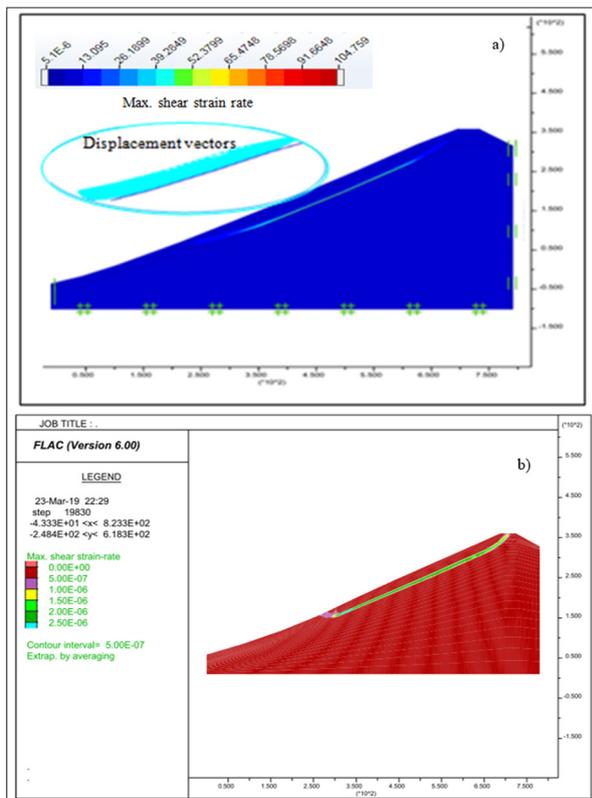
Figure 21. Comparison between the results of the two softwares a) limit analysis. b) finite difference analysis (low piezometric height).

In addition, the results of long-term calculations carried out by the OptumG2 software (Figure 21.a) represent the failure mode obtained for all probable hydraulic boundary conditions in association with the high mechanical strength of the existing schist. They make it possible to demonstrate a quasi-plane failure affecting an extended length of the slope. This failure starts on the front part of the slope contrary

to the result of calculation obtained by the software Flac, whose failure has covered a significant part of the urbanized area (Figure 18, 20 and 21b). In any case, the results of both calculations are consistent with regards to the volume, the thickness, and the nature of the lands set in motion.

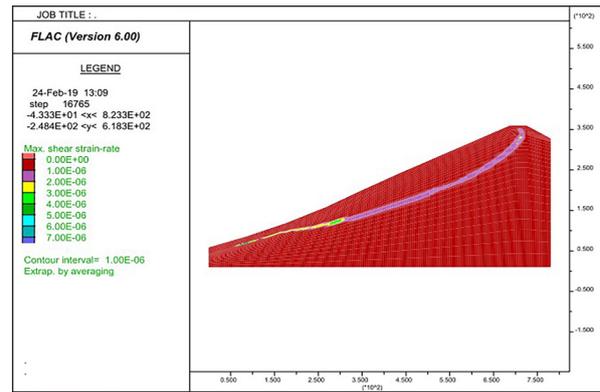
Figure 22. Failure mechanism 4 (Average drainage level and low cohesion)

The sliding spreads over a larger part of the slope which shows a mobilization of a thick slice of the substratum (Figure 22). It appears that the lower is the cohesion of the substratum, and the greater is the depth of failure. It is worth noting that this configuration represents the presence of a thick layer of a crushed schist or the presence of poor mechanical characteristics where discontinuities appear. Current knowledge tends to show that this deformation mode seems to be very unrealistic. It shows, however, that the mode of failure depends explicitly on the current mechanical strength of the rock. Therefore, precise knowledge of the current geological structure of the rock massifs should provide answers to this question regarding the possibility of failure or a very deep potential failure.
