# Building Collapse in Nigeria and its Consequences on the Architect's Role as the Leader of The Building Team

Obi. I. Nicholas<sup>1</sup>, Nwalusi, M. Dickson<sup>2</sup>, Francis O. Okeke<sup>3\*</sup>

<sup>1,2,3</sup> Dept. of Architecture, University of Nigeria

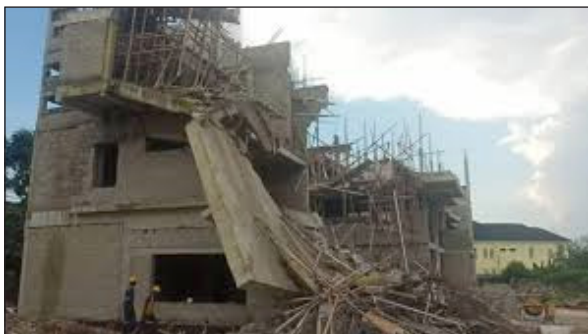
**Figure 1.** Two -Storey Building that collapsed in Lagos, Nigeria (2019)  
Source: Olasunkanmi, (2019)

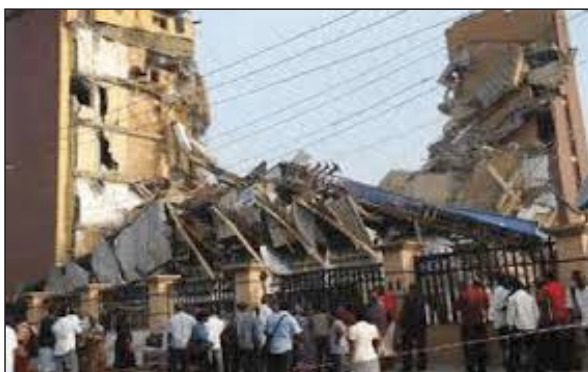
**Figure 2.** Collapse of Two -Storey Building in Delta State, Nigeria (2015)  
Source: Chido, (2015)

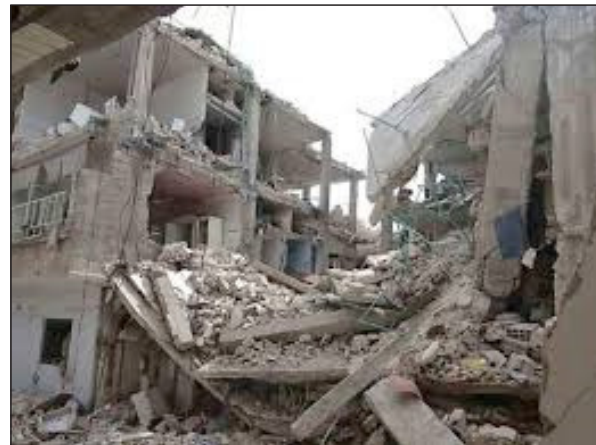
**Figure 3.** School Building Collapse in Lagos, Nigeria 2019  
Source; Rayyan, (2019)

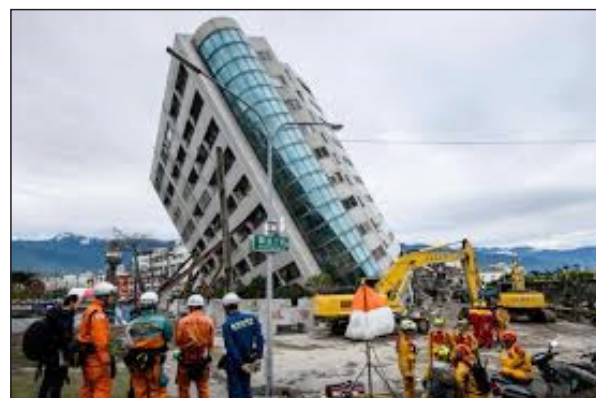
**Figure 4.** A Collapsed Building caused by Earthquake in Taiwan 2018  
Source: the Associated Press, (2018)

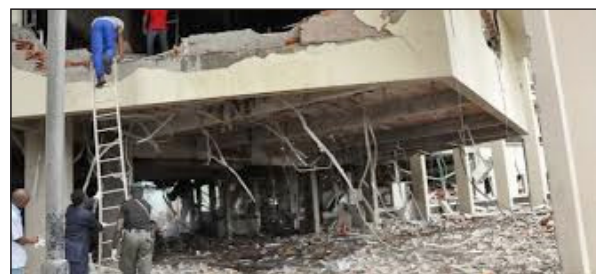
**Figure 5.** Collapse of multistorey building in Agbama, Umuahia, Nigeria (table 1, No. 25)  
Source: Babalola, (2015)

| 25 | Agbama, area, Umuahia | 15th May 2013 | Building under Construction | Not Reported <sup>7</sup> | 7 |
