# Kinematic Analysis of Landslides: A Case Study Along Jerash-Amman Highway, Jordan

Abdullah Diabat<sup>1</sup>, Majed Ibrahim<sup>2</sup>, Yasmeeen Al-Hawareen<sup>3</sup>

<sup>1,3</sup>Earth and Environmental Sciences Department, Al al-Bayt University, Al-Mafraq, Jordan

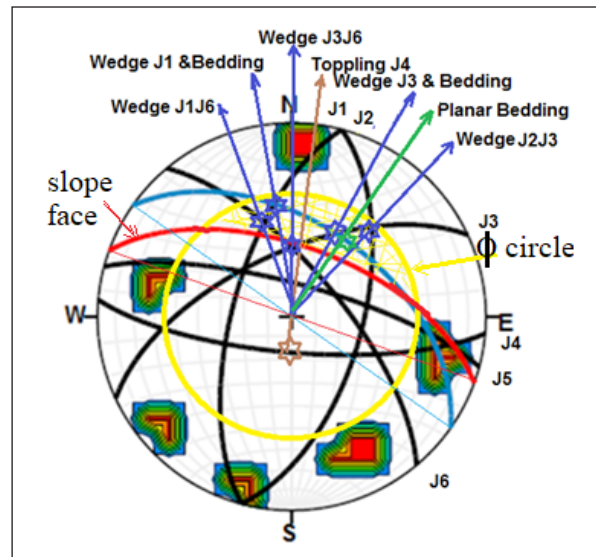
**Figure 6.** Example of stability estimate of the rock mass in station 5; black great circles represent planes corresponding to centres of pole concentrations of discontinuities probable to planar, wedge, and toppling failures, the blue great circle represents the bedding attitude, the red great circle represents the slope face and the shaded yellow sector represents the unstable area for sliding.

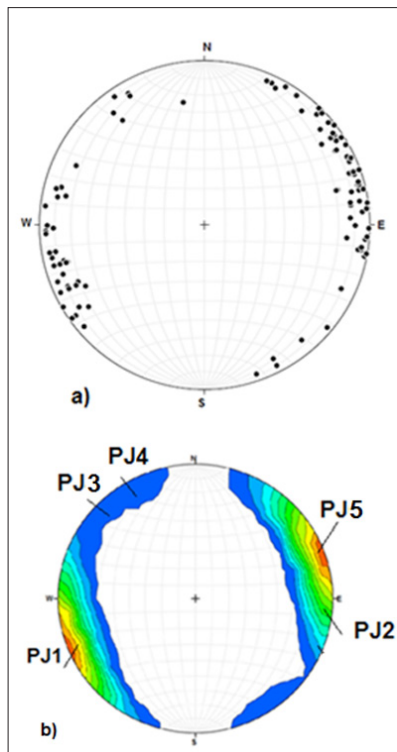
Figure 8. Figure (8a) represents the pole plot of all measured discontinuities. The contour plot in Figure (8b) represents the concentration of all discontinuity readings. The fractures and bedding plane (dip/dip direction 05/090) with slope face oriented (65/240) and the supposed friction angle 34° according to Dames and Moore (1993), were kinematically analyzed using stereographic projection (Fig. 9).

**Figure 8.** a) Pole plot of the discontinuities, b) Contour plot of main concentrations of poles.

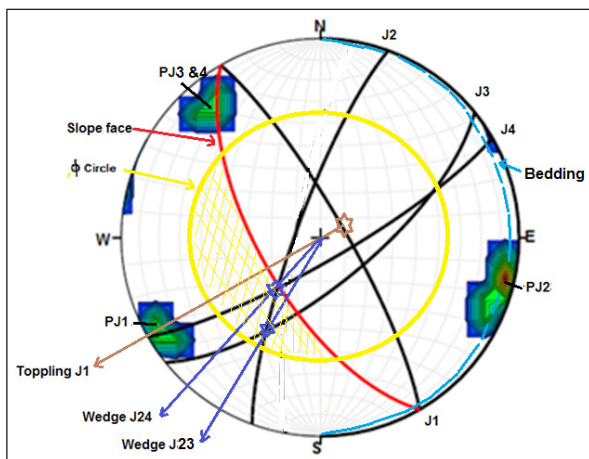
Five joint sets were determined and analyzed for stability (Figs 8b and 9); J1(80/075), J2 (80/290), J3 (68/140),

J4(80/150), and J5 (88/255). The result shows that probable toppling failure towards WSW (255 °) at J1 (Fig. 9), this is expected because the dip direction of the J1-set is in the opposite direction of the slope face. Figure (9) shows two wedge failure directions along the line of intersections of J2 and J3 (J23), J2 and J4 (J24), respectively towards 40/210° and 60/220°. It is important to note that the wedge sliding along J24 is in its critical case because the intersection point of J2 and J4 lies at the slope face (Fig. 9). Despite the dominance trend of J5 (Figs 8 and 9), the results of the kinematic analysis indicated that it is stable because the dip of discontinuity planes is greater than the slope angle and lying out of the area of probable failure. Figures 10 and 11 show examples of toppling and wedge failures in station 1, respectively.

**Figure 9.** Stability estimates of the rock mass in station1; Great circles representing planes corresponding to centers of pole concentrations of discontinuities probable to toppling and wedge failure. The shaded yellow sector represents the unstable area for sliding.

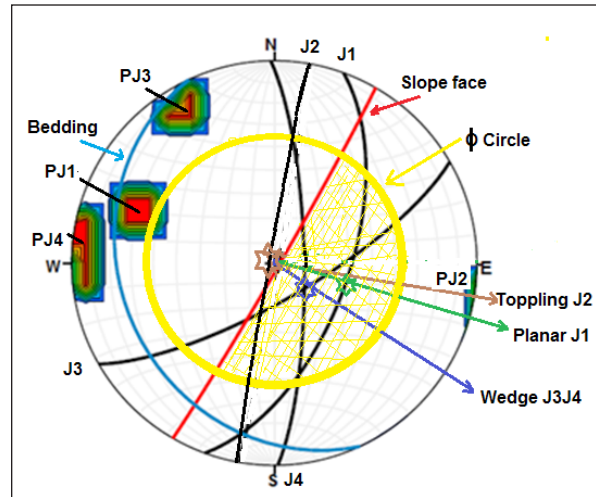
The fractures and bedding plane (dip/dip direction 245/25°) with slope face oriented (120/88°) and the supposed friction angle 34° according to Moor (1993), were kinematically analyzed using stereographic projection. Four joint sets were determined and analyzed for stability (Figs. 13b and 14); J1 ( 60/110), J2 (86/280), J3 (70/150), and J4 (75/ 090). The results show that probable plane sliding along J1 with an attitude of plunge/ plunge direction 60/110 (Fig. 14). Toppling failure towards ESE (100°) at J2 (Fig. 14), is expected because the dip direction of the J2-set is in the opposite direction of the slope face. Fig. 14, also shows a wedge failure along the line of intersection of J3 and J4 (J34) towards 75/125°.

**Figure 14.** Stability estimates of the rock mass in station-2; Great circles representing planes corresponding to centers of pole concentrations of discontinuities probable to toppling and wedge failure. The shaded yellow sector represents the unstable area for sliding.

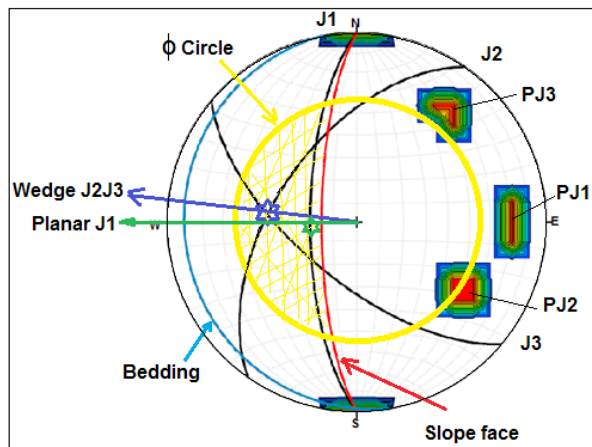
The fractures and bedding plane (dip/dip direction  $260/10^{\circ}$ ) with slope face oriented ( $270/75^{\circ}$ ) and the supposed friction angle  $34^{\circ}$  according to Moor (1993) were kinematically analyzed using stereographic projection (Fig. 17). Three joint sets were determined and analyzed for stability (Figs 16b and 17); J1( $70/ 270$ ), J2 ( $50/ 300$ ) and J3 ( $50/ 220$ ). The results show that probable plane sliding along J1 with an attitude of  $85/ 270$  and a wedge failure along the line of intersection of J2 and J3 (J23) towards WNW ( $60/ 280^{\circ}$ ).

**Figure 17.** Stability estimate of the rock mass in station-3; Great circles representing planes corresponding to centers of pole concentrations of discontinuities probable to toppling and wedge failure. The shaded yellow sector represents the unstable area for sliding.

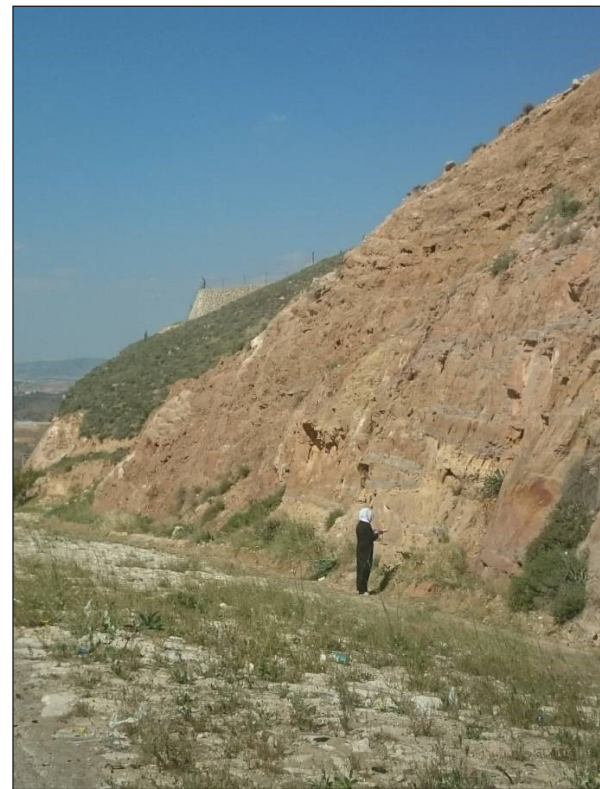
This station is located along Jerash-Amman Highway about 15 Km to the south of Jerash. It is located at  $32^{\circ} 11.713' N$  and  $35^{\circ} 51.878' E$  (Fig. 3). The outcrop is part of the Kurnub group, massive yellowish to white grey cliffs separated by poorly exposed friable sandstone (Fig. 18). Figure (19a) represents the pole plot of all measured discontinuities. The contour plot in Fig. (19b) represents the attitude of all concentration discontinuities.

**Figure 18.** Kurnub outcrop in station-4.

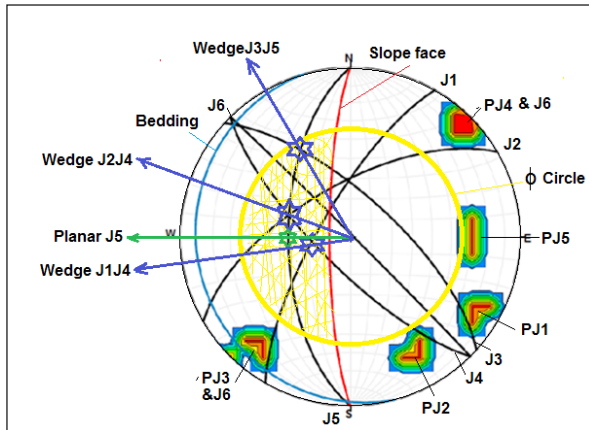
The fractures and bedding plane (dip/dip direction  $10/270^{\circ}$ ) with slope face oriented ( $270/85^{\circ}$ ) and the

supposed friction angle  $34^{\circ}$  were kinematically analyzed using stereographic projection (Fig. 20). Six joint sets were determined and analyzed for stability (Figs 19b and 20); J1( $80/310$ ), J2 ( $70/330$ ), J3 ( $75/050$ ), J4 ( $75/230$ ), J5 ( $70/270$ ) and J6 (vertical, strike  $140$ ). The results show that a probable plane sliding along J5 toward the west with an attitude of  $70/270$  (Fig. 20) and three wedge failure directions; the first along the line of intersection of J1 and J4 (J1J4) towards WNW ( $70/260^{\circ}$ ), the second along J2J4 ( $70/290$ ) and the third along J3J5 ( $40/330$ ).

**Figure 20.** Stability estimate of the rock mass in station-4; Great circles representing planes corresponding to centers of pole concentrations of discontinuities probable to toppling and wedge failure. The shaded yellow sector represents the unstable area for sliding.

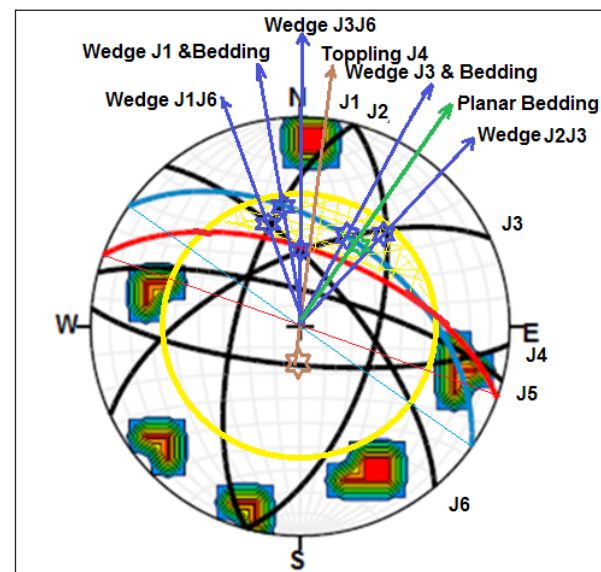
The fractures and bedding plane (dip/dip direction 50/ 035°) with slope face oriented (60/ 020°) and the supposed friction angle 34° according to Moor (1993) and (Table 2), were kinematically analyzed using stereographic projection (Fig. 23). Six joint sets were determined and analyzed for stability (Figs 22b and 23); J1(65/ 280), J2 (65/ 100) and J3 (60/ 330), J4 (70/ 185), J5 (70/ 020) and J6 (70/050). The results show that probable plane sliding along bedding planes with an attitude of 50/ 030, because the strike of bedding is sub-parallel to the strike of slope face (Figs 23 and 24), and a toppling failure of J4 towards NNE (010) (Figs 23 and 25). In figure (25) a tension crack acting as a back release surface was observed. Five wedge failure directions are expected;

the first is along the line of intersection of J2 J3 (J23) towards (30/ 040), the second is along the line of intersection of J1J6 towards (35/ 342), and the third is along the line of intersection of J3J6 toward the north, the fourth is along the line of intersection of J1 and bedding towards 30/350, and the fifth is along the line of intersection of J3 and bedding towards 40/ 058 (Fig. 23).

**Figure 23.** Stability estimate of the rock mass in station-5; Great circles representing planes corresponding to centers of pole concentrations of discontinuities probable to planar, wedge, and toppling failures. The shaded yellow sector represents the unstable area for sliding

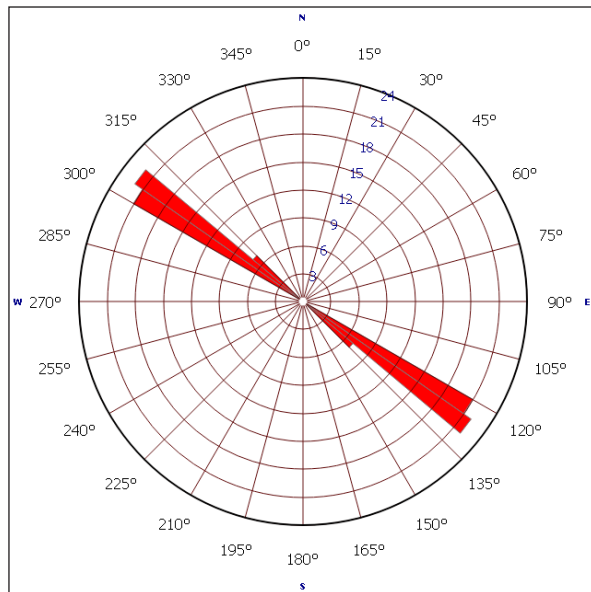
soft green clay at the base (Fig. 26). Fifty fractures were measured and represented in the rose diagram and shows the main trend of NW-SE (Fig. 27). The attitude of the slope face and bedding planes are parallel and equal  $280/30^{\circ}$  (Fig. 28). The kinematic analysis of this station, shows that the outcrop was stable and at the critical case for plane sliding because the great circles of the bedding and slope face are less than the friction angle and located out of the friction circle (Fig. 28). The measured joints in this station do not affect the sliding as their strikes are making an angle about  $60^{\circ}$  with bedding and the intersection line is out of the friction circle (Fig. 28).

**Figure 27.** The strike of the main trend of the fractures in station-6.

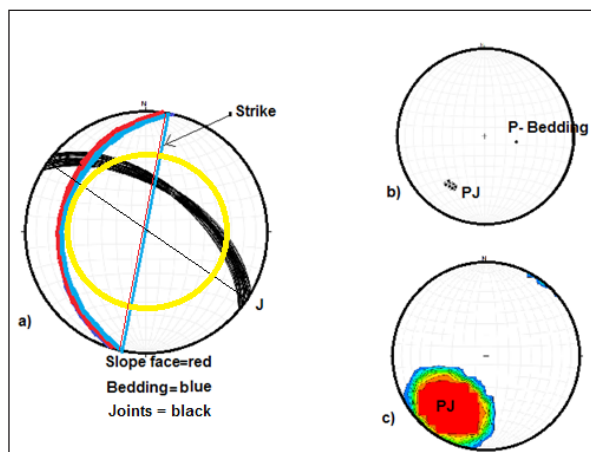
**Figure 28.** Stereonet diagrams represent the discontinuities (black great circles), slope face (red great circle), and plane sliding along bedding planes (blue great circle) in station 6.

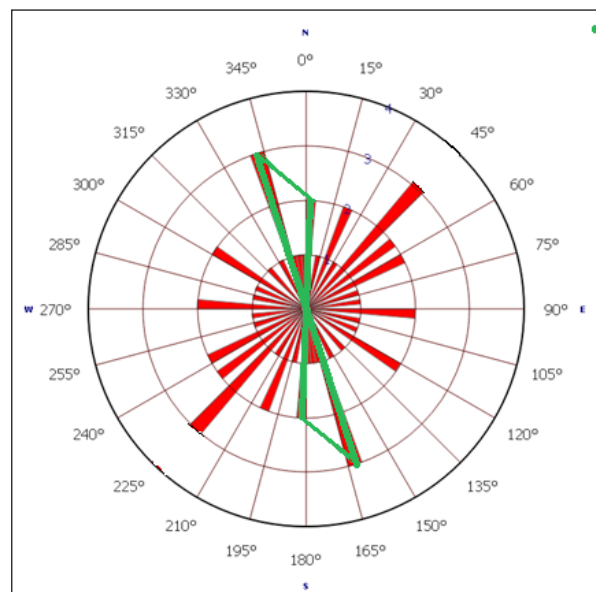
**Figure 34.** Strike measurements of randomly (no preferred orientation) oriented fractures in station-9; the green marked trend represents the toppling fractures set.

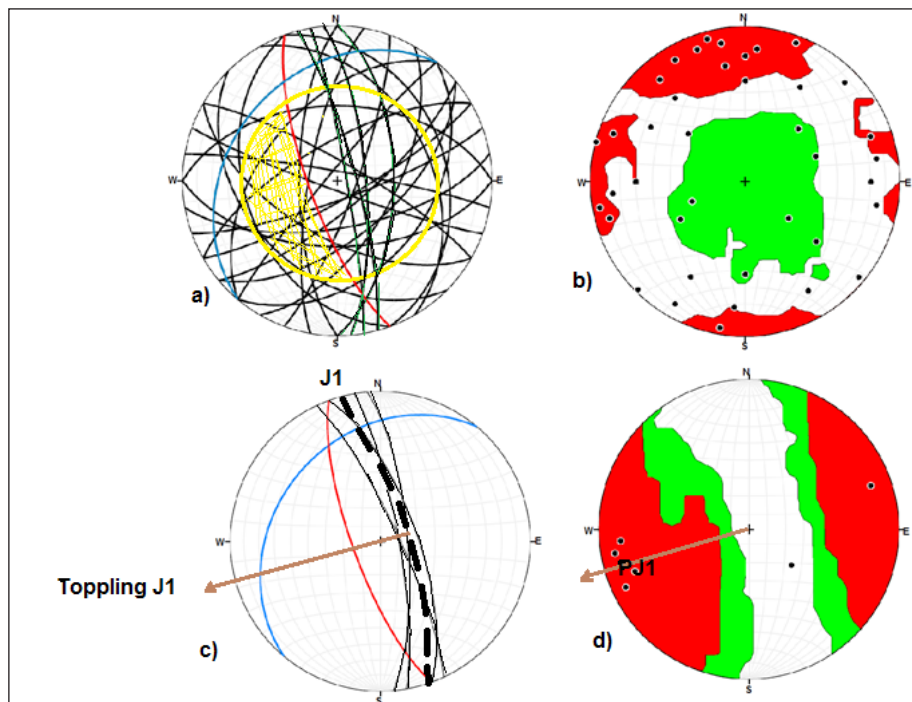
This station is located along Jerash-Amman Highway about 25 Km south of Jerash. It is located at  $32^{\circ} 9.76'N$  and  $35^{\circ} 50.835' E$  (Fig. 3). The outcrop in the study site is Fuheis Formation, which is dominated by marls and marly nodular limestone. It also consists of soft, friable marls intercalated with lenses of calcareous--mudstone, thin beds of nodular and fossiliferous limestone. The outcrop is highly fractured in all directions, and highly weathered (Fig. 34). The high density of the fractures and the cohesionless of these fractures led to the circular failure as there is no preferred orientation for them (Fig. 35). Some fractures with preferred orientation NNW-SSE to N-S are also present in this station (Fig. 36). These fractures (J1) beyond the rock mass act as back release (tension cracks), and will be topple in this station (Fig. 36). The kinematic analysis of this station is shown in (Fig. 37).

Figure 37. a) Stereographic projection (great circles) of the fractures, b) Poles of the fractures (no preferred orientation), c) Toppling failure along J1 towards WSW, d) poles of J1 (PJ1).

Station-9 has highly fractured rocks which resulted in a circular failure, whereas some fractures with preferred orientation in NNW-SSE to N-S resulted in toppling. These fractures (J1) beyond the rock mass act as the back release (tension cracks) and will lead to toppling. The results of the kinematic analysis in the study area show that the wedge failure in stations 1, 2, 3, 4, and 5 between joints (J2 and J4, J2 and J3), (J3 and J4), (J2 and J3), (J1 and J4, J2 and J4, J3 and J5), (J1 and J6, J1 and bedding, J3 and J6, J3 and bedding, J2 and J3). Toppling failure in stations 1, 2, 5, and 9 between the joint sets J1, J2, J4, and J1, respectively. Plane failure in stations 2, 3, 4, and 5 along the joint sets J1, J1, J5, and bedding, respectively. Whereas, circular failure was only observed in station 9. Based on the results of the current study the landslides were delineated and displayed on the land sat and on the geological map of the study area (Fig. 38).

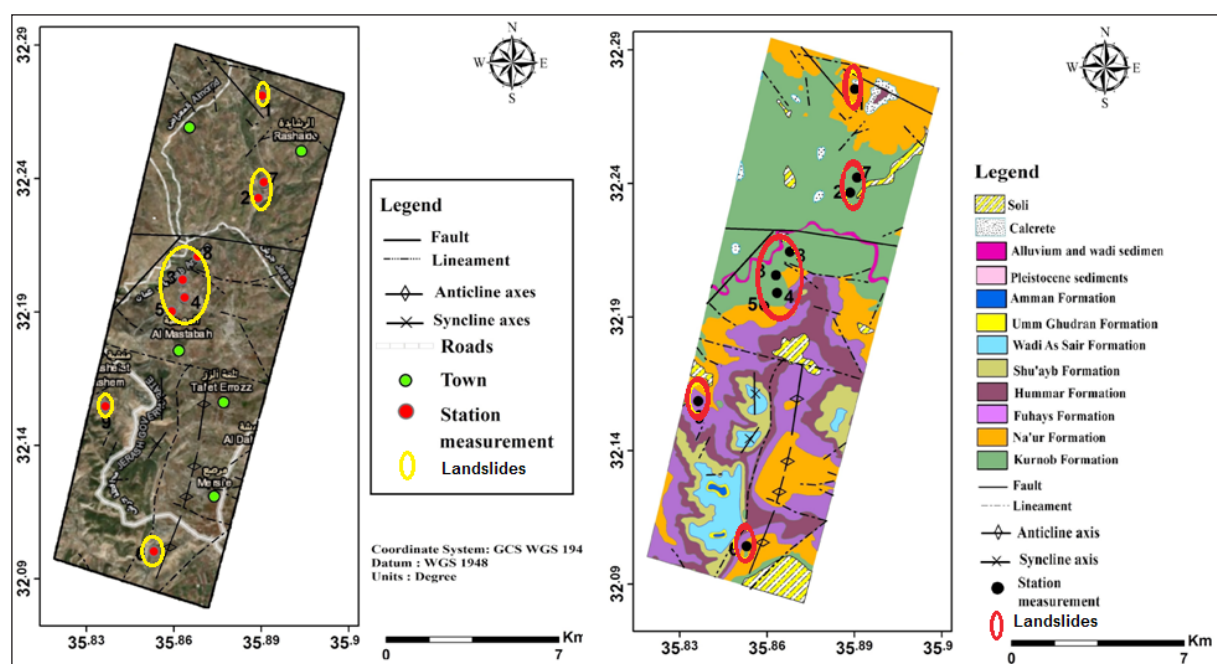
**Figure 38.** The delineated landslides (red and yellow ellipses) displayed on the land sat satellite image(Explorer 2018)and geological map, respectively.

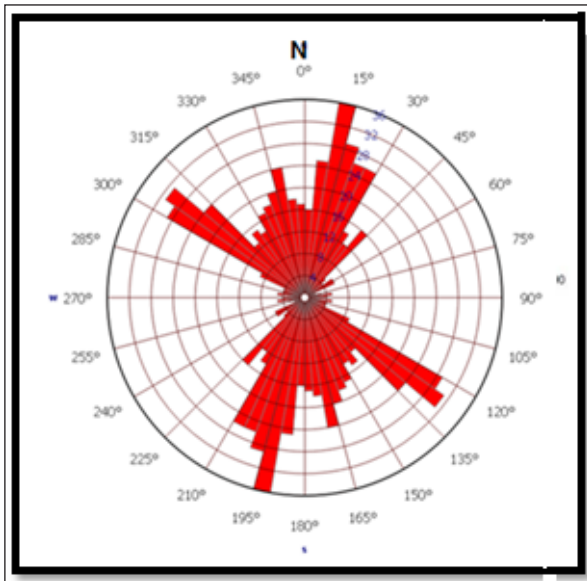
All measured microfractures with a total of 500 readings were represented in a rose diagram (Fig. 39). From the figure it can be inferred that the main trend is generally NNE - SSW. It is observed that the strike of the main trend of the fractures in stations 2, 3, and 4 ( NNE to N) is parallel to sub-parallel to the strike of the slope face. In stations 1 and

5, the minor trends (NNW to NW) are sub-parallel to the slope face. In station-6 the fractures are oblique to slope face at about 45 degrees. In station-9 it is parallel to the toppling planes only in the NNW-SSE direction. This indicates the major role of the structures in rock landslides, particularly those related to planar, and toppling failures as they are sub-parallel to slope faces.

**Figure 39.** Strike measurements of all measured fractures in the study area
